CASE REPORT

Femoral neck fracture following intramedullary nailing with misplacement of an end cup: report of two cases

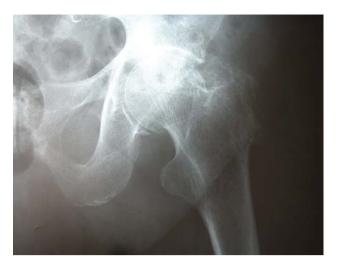
Fig. 5 Magnified view of the femoral neck region (same radiogram as in Fig. 4)—apparently healthy femoral neck

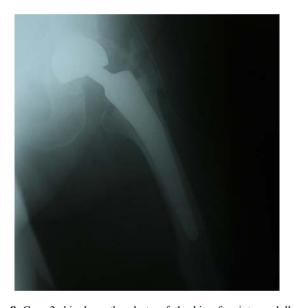
Fig. 8 Case 2: bipolar arthroplasty of the hip after intramedullary nail removal

The patient presented with symptoms two weeks after discharge. X-ray examination revealed an AO 31-B3 FNF (Fig. 7). The patient was reoperated after seven weeks with symptoms of bone union of the femoral shaft. The nail was removed and bipolar arthroplasty of the hip was performed (Fig. 8). The subsequent postoperative course was uneventful.
