## Early catastrophic acetabular failure in Furlong total hip replacements

**Keywords** Ceramic on polyethylene articulation · Furlong replacement · Acetabular failure

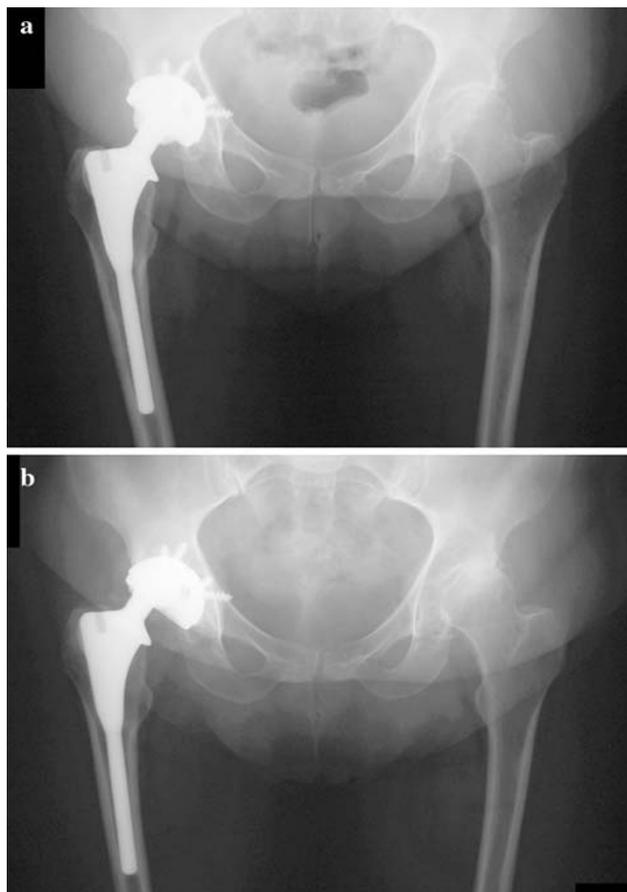
Seven years later she presented to her family doctor complaining of a recurrence of right hip pain. An X-ray was performed and was reported as normal. Her pain persisted and a repeat X-ray was again reported as normal. She was reviewed in our institution 21 months after her recurrence of pain. Examination revealed a good range of movement in all planes, but there was gross audible crepitus. The right leg was shorter than the left. A comparison of the X-ray films is shown in Fig. 1a and b.

There were no radiolucencies and no measurable migration of either component was present. There was no osteolysis. On the later film there was very evident failure of the polyethylene liner and migration of the ceramic head.

**Fig. 1** Comparison of AP X-rays performed two years apart after recurrence of symptoms

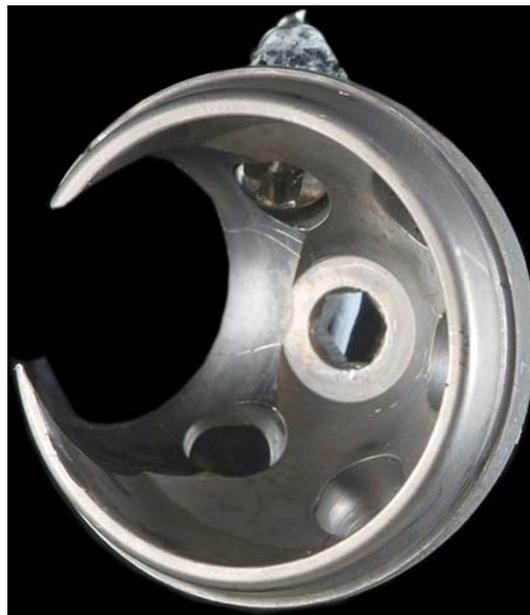
At revision the femur was found to be solidly fixed. Tissues surrounding the acetabulum were heavily stained with black metallosis. The femoral head had eroded through the polyethylene liner and continued through the roof of the titanium acetabular component to rest on the acetabular bone (Fig. 2). The acetabular prosthesis, despite this, remained securely fixed. There was no suggestion of infection and no abnormality in the original positioning of the components. The acetabular component was revised to a similar 52 mm HA-coated CSF Furlong cup secured with four cancellous screws. The head was replaced with a 28 mm cobalt chrome Furlong head. This patient recently required further acetabular revision 11 years post initial primary arthroplasty. On this occasion, the acetabulum was exchanged for a cemented Ogee (De Puy, Leeds, UK) cup due to persistent pain and evidence of acetabular aseptic loosening. Again the femoral component was solidly fixed at operation and left in situ. According to the images in

**Fig. 2** The ceramic femoral head had eroded through the polyethylene liner and metal acetabular component. The heads of the cancellous fixation screws were also worn

These cases illustrate dramatic abrasion of the polyethylene, cancellous screws and metal acetabulum. In the first example, this occurred in the presence of no apparent prosthesis malpositioning; however, in the later case, a rather steep cup inclination with a cup abduction angle of  $52^\circ$  may have played a contributing role. Neither case showed evidence of defective implant manufacture, nor were there initial radiographic signs of osteolysis, migration or loosening. All components were found to be solidly fixed at the time of revision and the femoral components were left in situ.

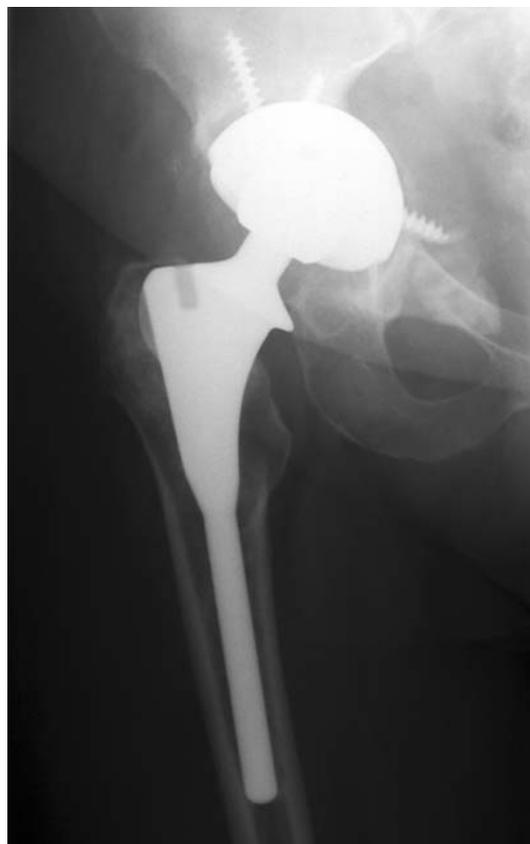
Figs. 3 and 4, there was evident resorption of the femoral calcar, but this does not appear to have adversely affected femoral stability.

**Fig. 3** Appearance 11 years post primary replacement and two years post acetabular revision. Failure of acetabular integration is evident

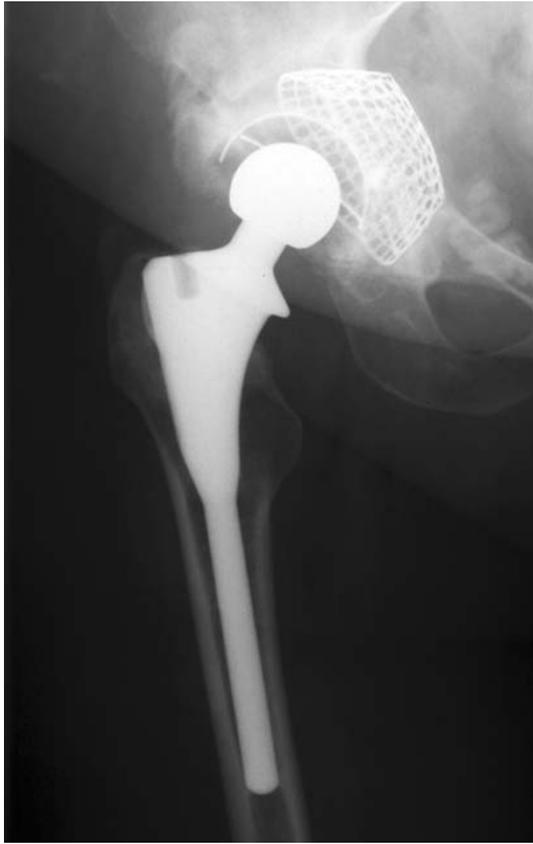
**Fig. 4** Two months post cemented acetabular revision. The femoral component remains solidly fixed despite calcar resorption

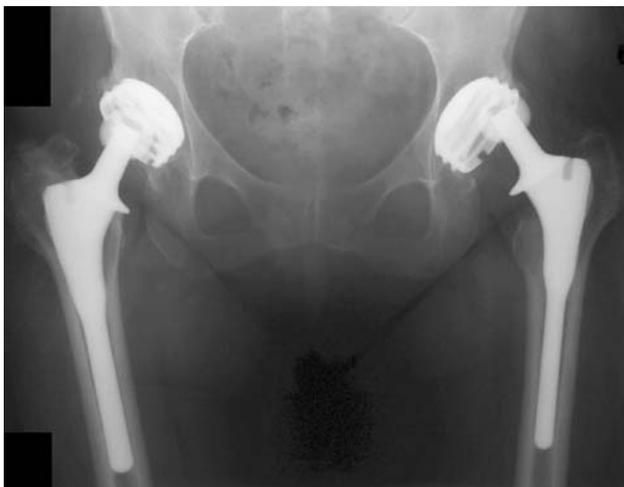
In a similar case, a 58-year-old lady was referred to our clinic complaining of left hip symptoms three years after having undergone bilateral uncemented Furlong replacements for primary hip osteoarthritis. Hydroxyapatite-coated, titanium-threaded cups with 8 mm polyethylene inserts were fitted on the acetabular side and alumina ceramic heads were used in an effort to minimise wear. She made a good recovery and returned to work as a teacher but was urgently referred due to gradually increasing pain in the left groin and an audible squeak. X-rays showed no evidence of acetabular or femoral stem loosening; however, the femoral head lay eccentric in the polyethylene insert (Fig 5).

**Fig. 5** X-ray appearance three years post replacement

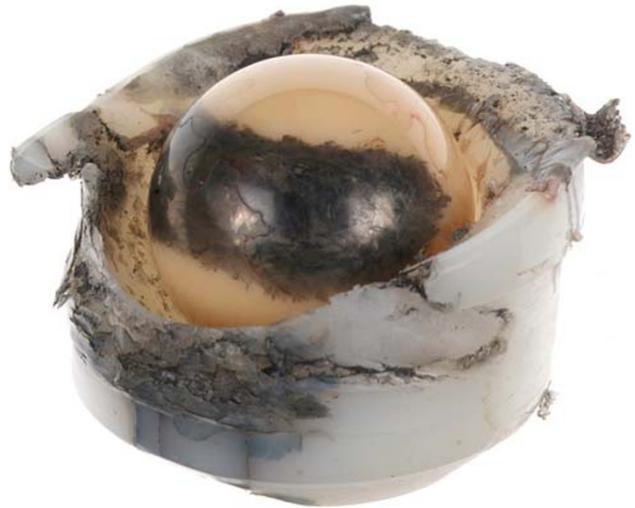
During revision there was moderate metallosis and staining of the tissues. The acetabular and femoral components were solidly fixed in position; however, the ceramic head had eroded through both the lip of the polyethylene liner and the lateral rim of the titanium cup

**Fig. 6** Erosion of the polyethylene liner and resulting metallosis and staining

(Fig. 6). There was no evidence of infection or prosthesis loosening. Again this was revised to a similar uncemented Furlong HA-coated acetabular component, and the patient initially appeared to make a good recovery.
