A. Katzer
A. Ince
M. Hahn
M.M. Morlock
W. Steens

Cement mantle defects in total hip arthroplasty: influence of stem size and cementing technique

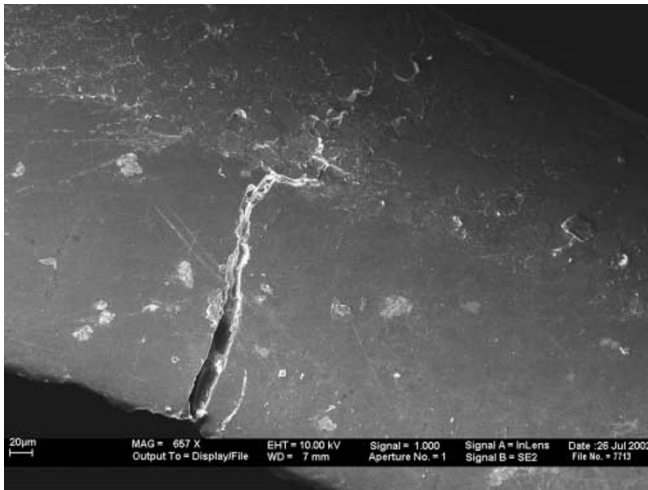
Fig. 2 View under the scanning electron microscope of a sample from section 1 (vacuum mixed cement, stem size 5, 657x magnification). A 150 μm crack beginning in the area between the prosthesis and the bone cement is seen

As unevenness of the cement surface renders the search for cracks difficult (Fig. 2), both surfaces of each section were polished with SiC abrasive paper on a polishing machine (Knuth – Rotor 2; Struers, Willich, Germany) with simultaneous water rinsing by hand or by means of two automatic sanding machines (EXAKT Apparatebau, Norderstedt, Germany). The grain of the abrasive paper was successively increased from 120 to 4000 so that the final coarseness of the surfaces was about 5 μm . Both surfaces of each section were then dyed using a black permanent marker and immediately cleaned with ethanol. The good contrast between the pore surface and the rest of the cement surface (Fig. 3) made it possible to determine the pore area automatically using an image analysis system (IBAS 2000 Kontron; CK-Medical, Ergolding, Germany). The cement mantle was analysed for section 1 (distal section) and section 6 (proximal section).
